**REVISED PCB ABATEMENT WORK PLAN
THE METROPLITAN DISTRICT
NEPAUG DAM
BURLINGTON, CONNECTICUT**

PREPARED FOR:
The Metropolitan District
Hartford, Connecticut

PREPARED BY:
GZA GeoEnvironmental, Inc.
Norwood, Massachusetts

August 2011
File No. 01.0019395.70

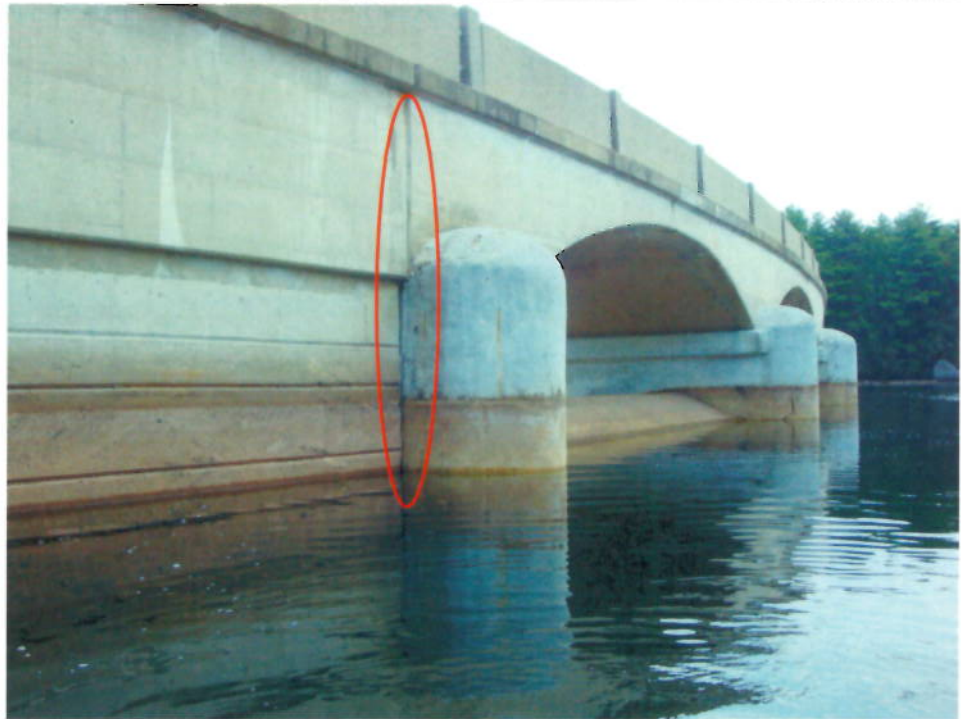
Description:
Joint 6/8
(Left Spillway Abutment)

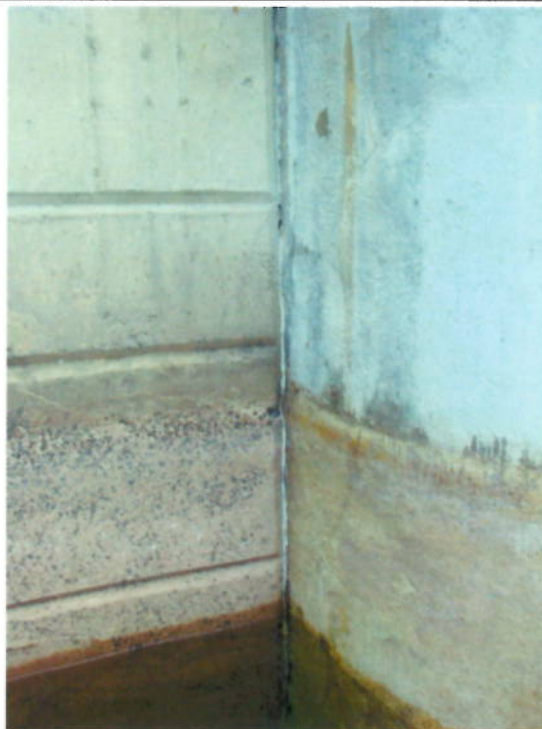
Photo No.
2

Description:
Close up of Joint 6/8

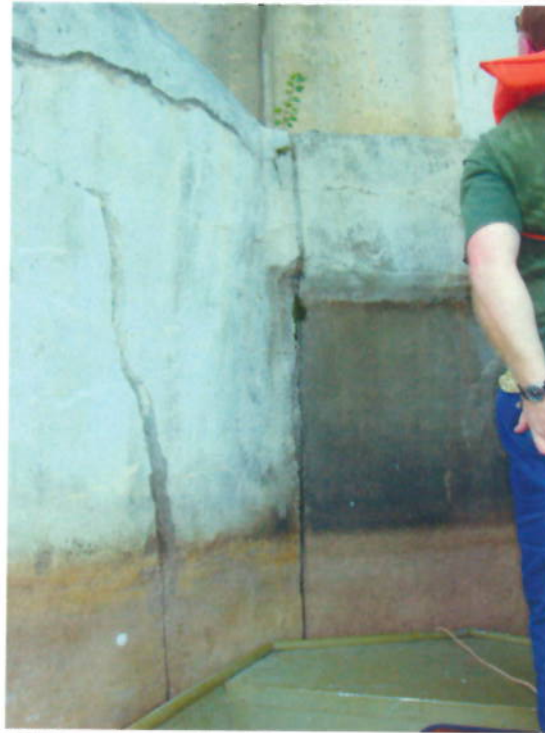
Joint 3/5, where cutwater meets upstream face of dam near right spillway abutment.

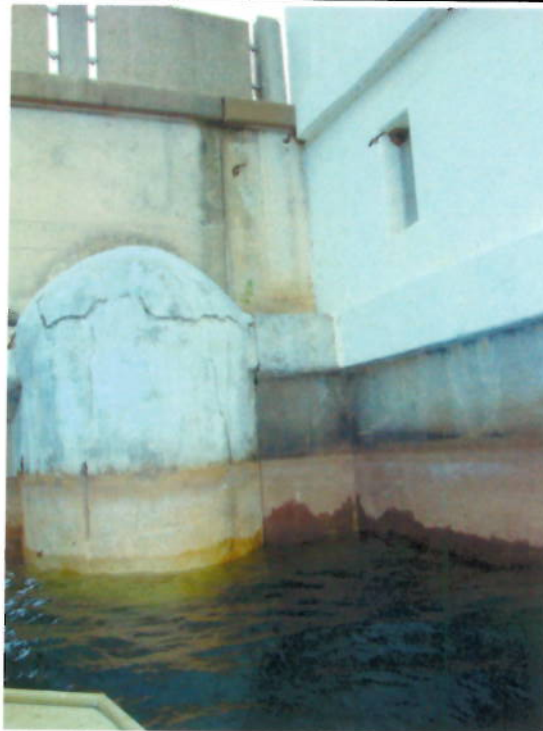
Photo No.
4

Description: Broader view of right spillway abutment cutwater, where it joins the face of the dam. Upper Gatehouse seen in the right-hand portion of the photograph.

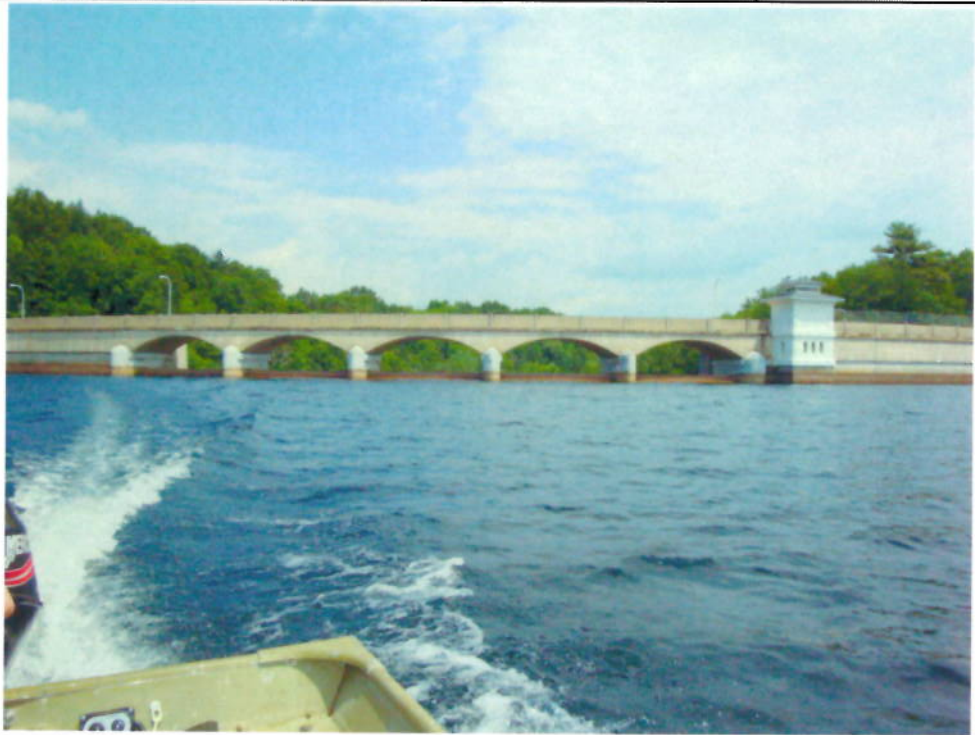
Description: Overview of Nepaug Spillway and Bridge

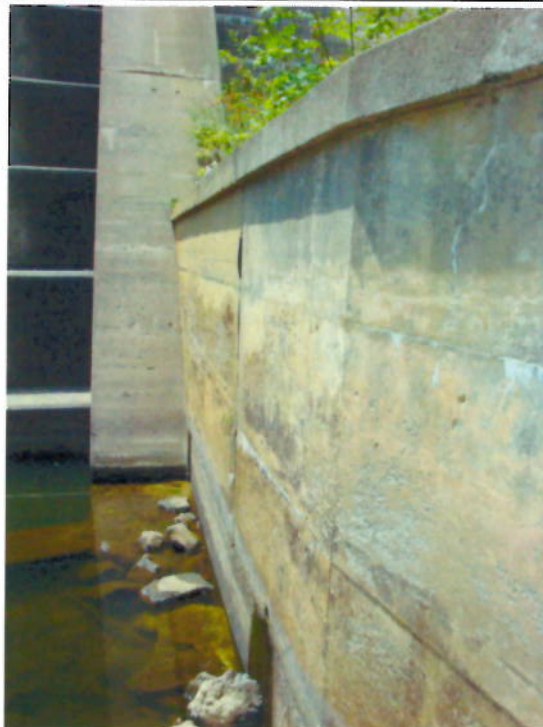
Photo No.
6

Description:
Left (west) Spillway Discharge Channel Wall

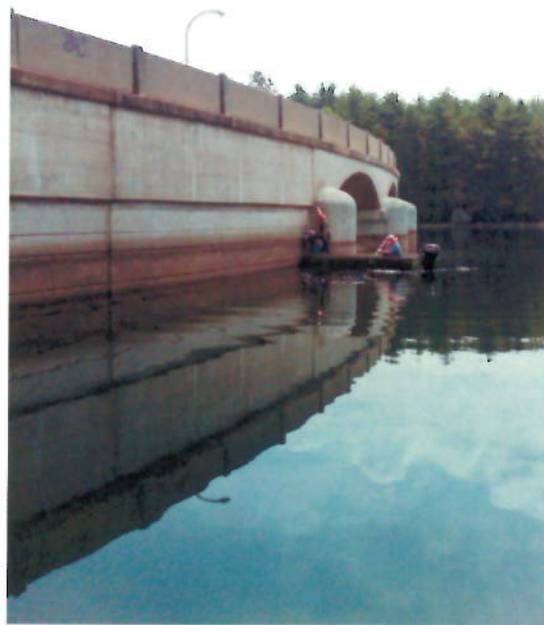
Description:
Sampling at Joint 6/8

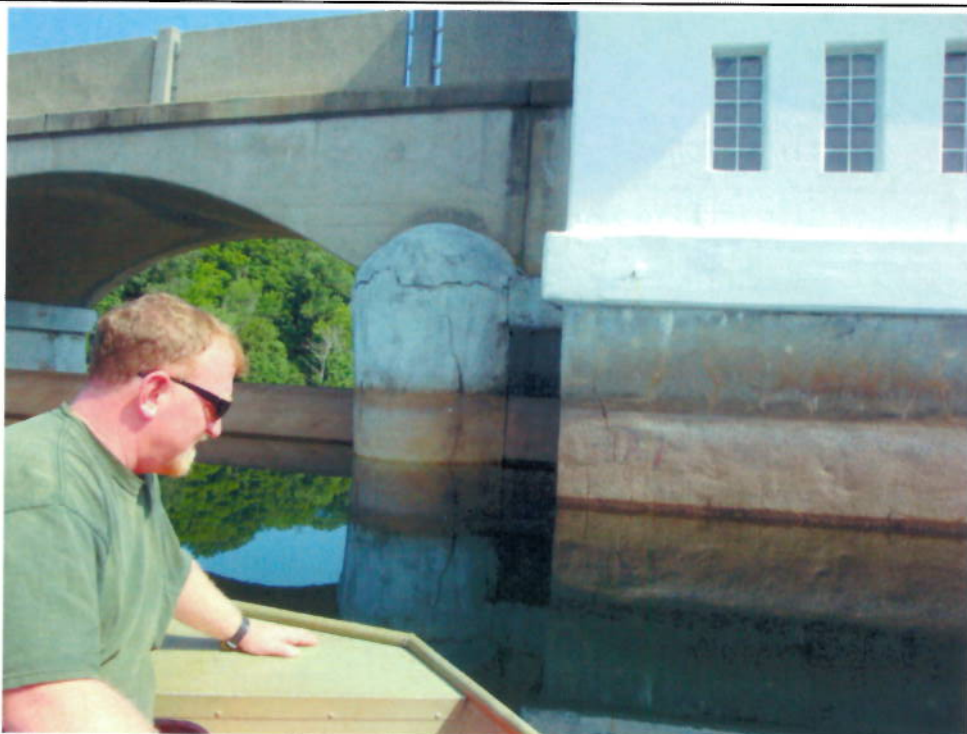
Photo No.
8

Description: Cutwater and Gatehouse adjacent to right abutment of spillway.

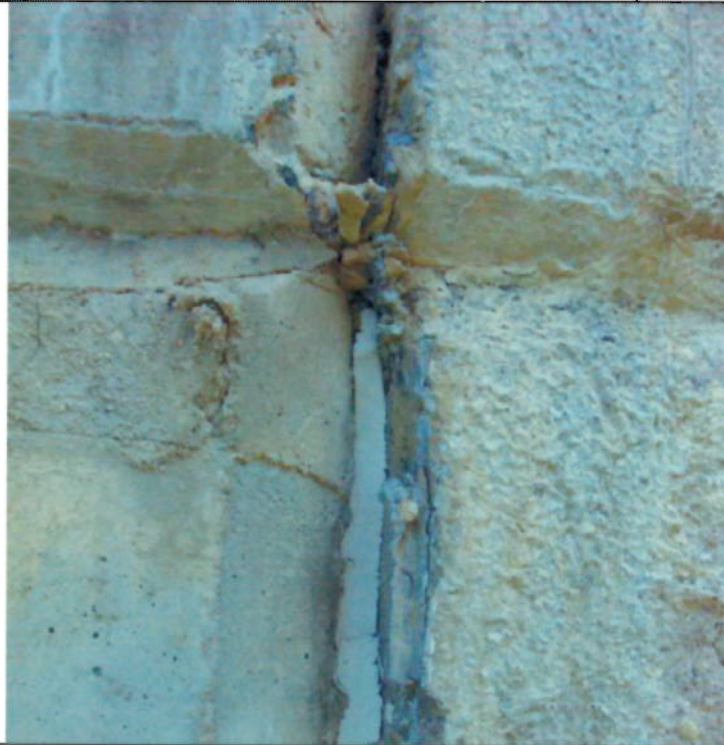
Close up of caulking at Joint 11/13 near eastern shore.

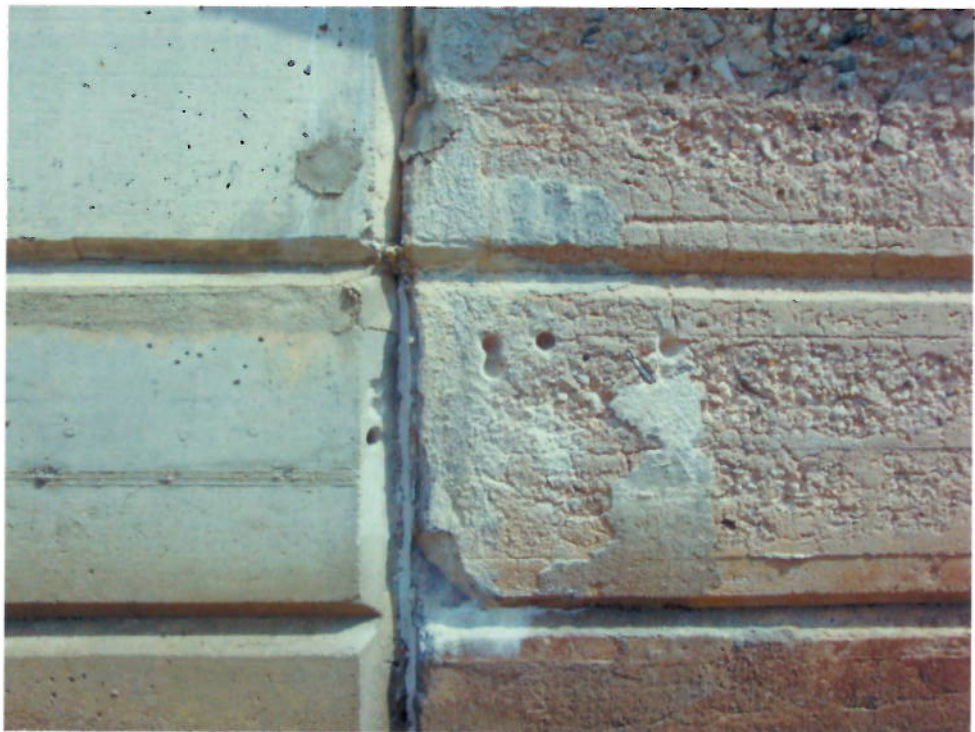
Photo No.
10

Caulk and Concrete Sampling at Joint 11/13
